COUNTRY East GermanyREPORT NO. TO: IC Schoenhauser Damm Airfield

DATE OF CONTENT 16 January to 4 March 1953DATE OBTAINED DATE PREPARED 26 May 1953

Schoenhausen Dam Airfield

Annex to Vol-3133

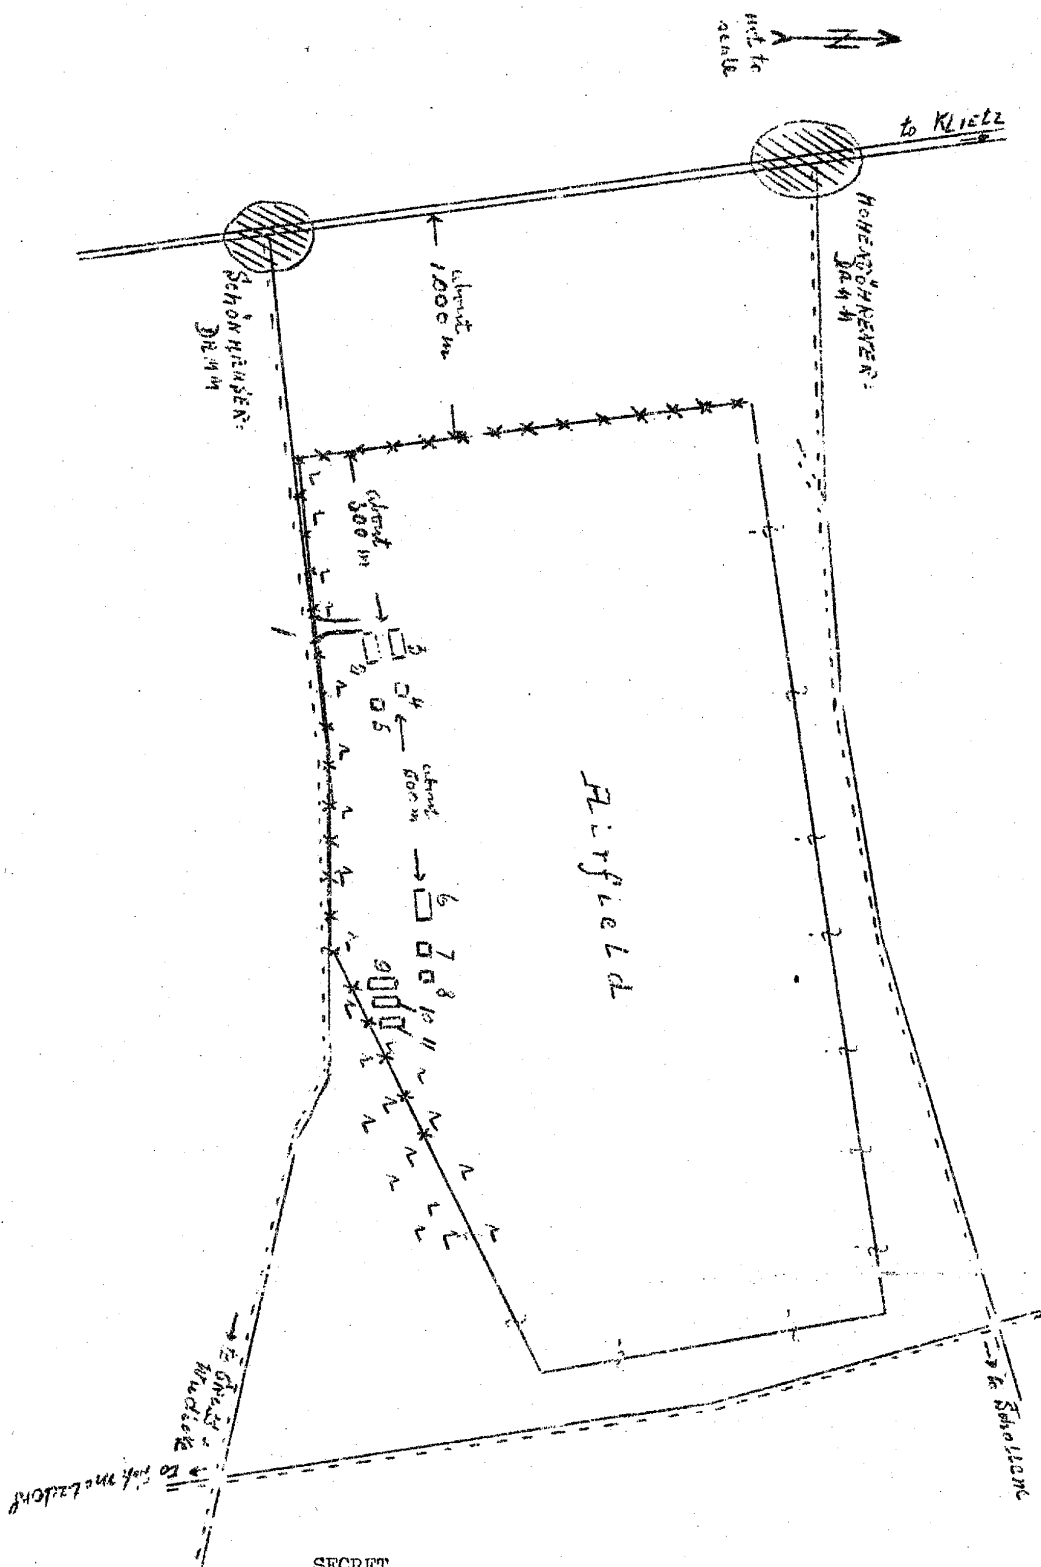
- 1 Wooden gate four meters wide
- 2 Foundations for a temporary wooden building
- 3 Temporary wooden building 15 x 7.5 meters
- 4 and 5 Small wooden sheds for the storage of equipment
- 6 Temporary quartering building about 20 x 9 meters
- 7 and 8 Wooden sheds 4 x 5 meters
- 9, 10, 11 Piles of pierced runway planks

The steel planks had an estimated length of 3 to 3.5 meters and a width of about 40 cm

xxx Course of barbed wire fence

??? Course of wire fence undetermined
